A BRIEF DISCUSSION OF A RECENT EXPLOSIVE ACCIDENT AT THE NAVAL SURFACE WARFARE CENTER

Naval Surface Warfare Center/Indian Head Division

**28th DoD Explosives Safety Seminar
August 1998**

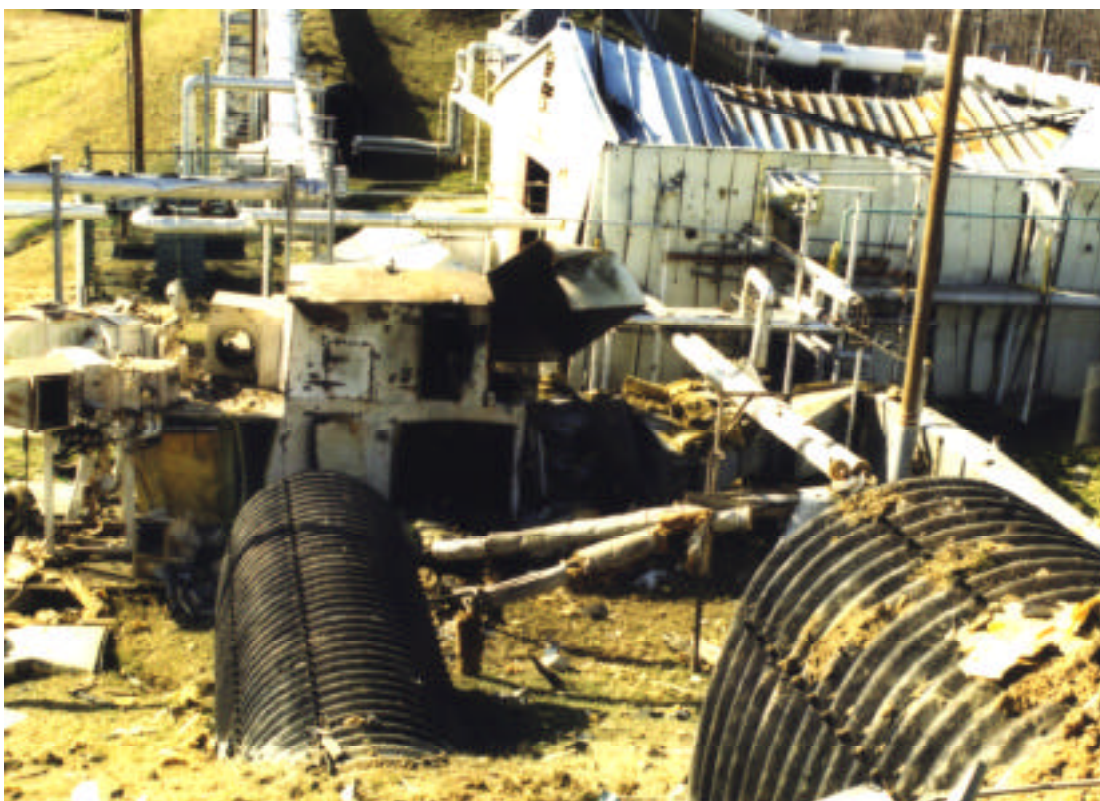
The damage that was observed in the surrounding structures appeared to be directional rather than being symmetrical centered on the structure. This is attributed to the numerous tunnel entrances to the building. Under normal circumstances, the airblast from this type of event would be symmetrical. This phenomenon has been studied by NCEL (Naval Civil Engineering Laboratory, now Naval Facilities Engineering Service Center (NFESC)) and is described as airblast from a four wall, vented cubicle¹. In our situation, however, another event is superimposed on this airblast. That is the highly directional airblast that is directed out each of the tunnels. It is this non-classical, directed-flow airblast that causes the majority of the observed damage to the surrounding structures². The following figures (Figure 5 through Figure 9) show some of this damage.

FIGURE 6. VIEW FROM TUNNEL ENTRANCE

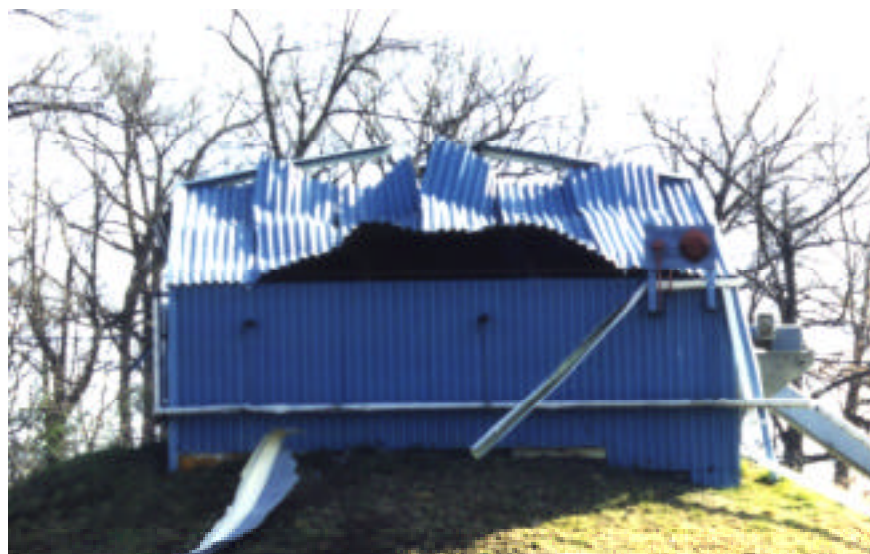
FIGURE 7. TYPICAL DAMAGE

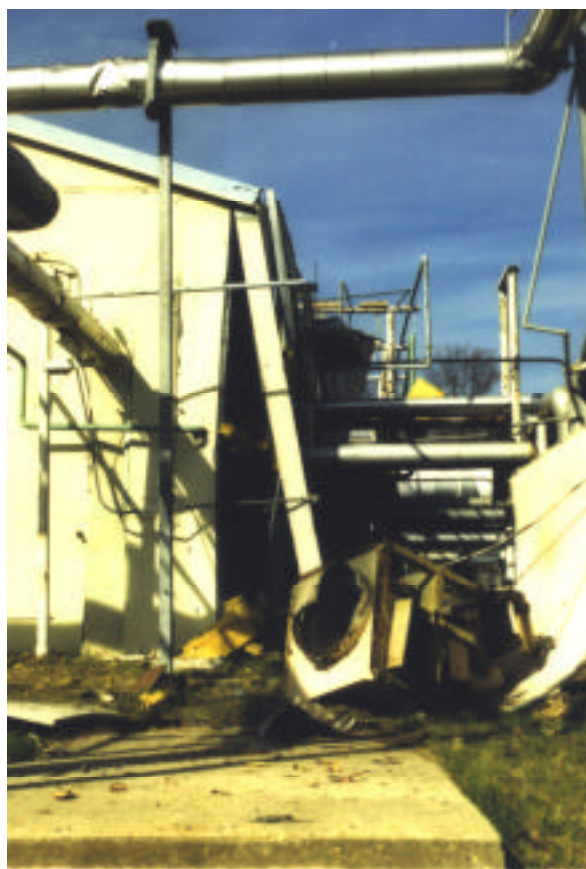
FIGURE 9. DAMAGE TO NEARBY EQUIPMENT BUILDING
